F-3-68 Frederick Cronise Farmstead Lewistown vicinity Private

F-3-68 Frederick Cronise Farmstead Lewistown Frederick County

Maryland Historical Trust State Historic Sites Inventory Form

Survey No. F-3-68

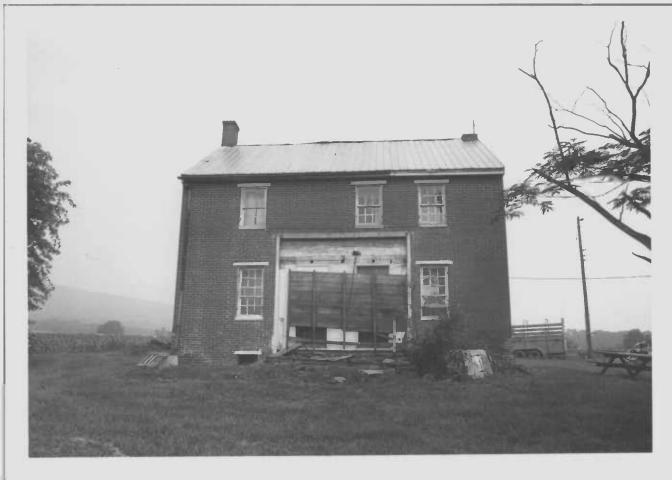
The dwelling has two stories and an irregular bay arrangement on the south The first story has four bays and the second story has three. Double entries are located in the inner bays and the exterior covering of stretcher bor. brick veneer is missing over the entrances, leaving the outline of an entry porch which has been removed, revealing the log structure of the house. Both entries are boarded, but a four-light transom is visible above one of the doorways. The windows are 6/6 with wood lintels and sills. The roof is covered with corrugated metal and standing seam metal on the north slope and the cornice is boxed. Interior end chimneys rise at each gable end. On the west elevation are two bays with 6/6 windows and 2/2 attic windows flanking the chimney. The east elevation has a single bay at the rear of the main section with 6/6 sash. A two-story rear wing extends from the northwest corner of the main section. It has 5:1 American bond and gauged arches, suggesting that it may have load-bearing brick walls and was added to the original log section in the second quarter of the 19th century. The wing has both 6/6 and 2/2 sash and a composition and pressed metal roof with a boxed cornice. Two chimneys are located in the wing. On the east elevation of the wing is a two-story integral porch which is enclosed on the first story and covered with german siding.

F-3-68 Frederick Cronise Formstead Frederick County Proto Jovet Covis September 1992 Neg-loc. And. SHPO Crownsville Ind. South Elevation

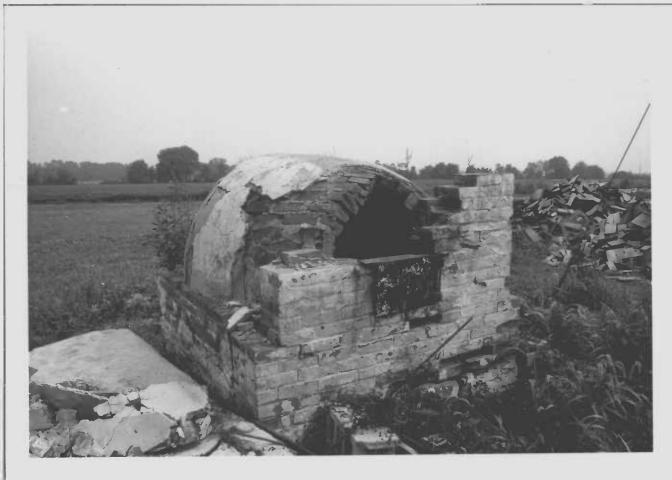
Bake oven: The separate bake oven is a rare surviving feature of the farmstead, although it is in deteriorated condition. It formerly had a frame gable roof protecting the domed top, but the roof is missing and the oven top shows the effects of exposure in missing bricks and plaster. On the south elevation is an iron door. Part of the wall structure in which it is set has fallen away, exposing the interior of the oven. The north side of the oven has the firebox and flue, both of which are in poor condition. The bake oven may date from about the late 1830's to the mid-1840's and was probably built at the same time as the house.

Bake oven, south elevation

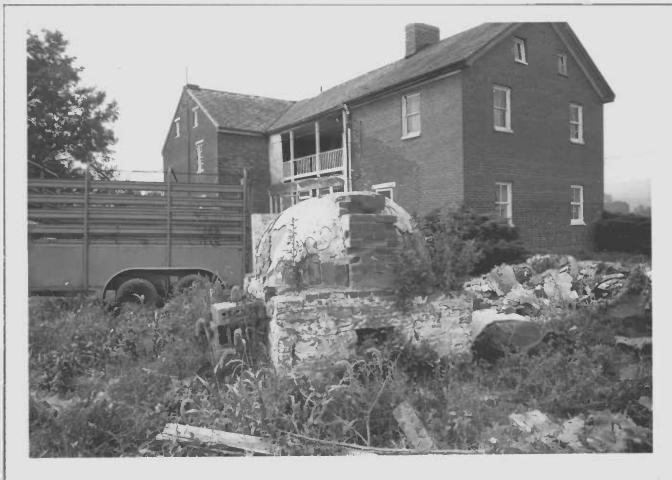
Bake over north elevation

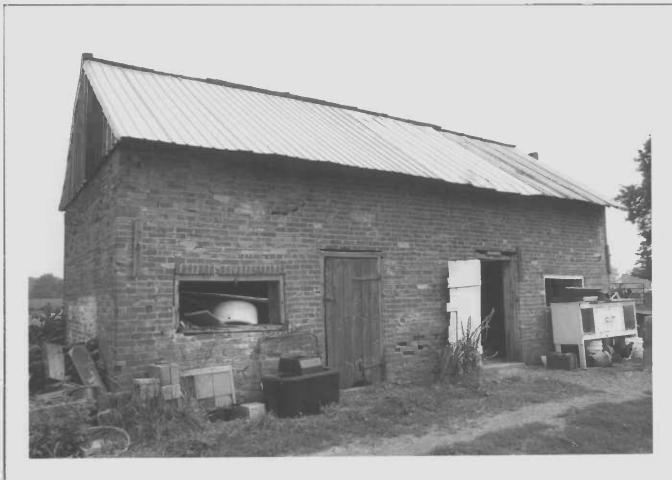
Blacksmith shop and summer kitchen: The brick combination building is located east of the bake oven. It has one story with two rooms. A loft above the east room is believed by the owner to have been slave quarters. The lower space has a large stone fireplace opening and an exterior stone and brick chimney is located on the east gable end. The west room apparently served as a blacksmith shop, with a forge enclosure still in place in the northeast corner. Both rooms are accessed through vertical board doors in the south elevation. The window openings are altered in a horizontal shape on this elevation and the north elevation has small 2/2 windows in each room. The gable ends are covered with board and batten siding and the roof is corrugated metal.

Frederick County Photo Janet Davis September 1992 Nea. loc. Md. SHFO, Crownsville, MA Block Shilth Shop & Summer Kitchen, South elevation 5/9

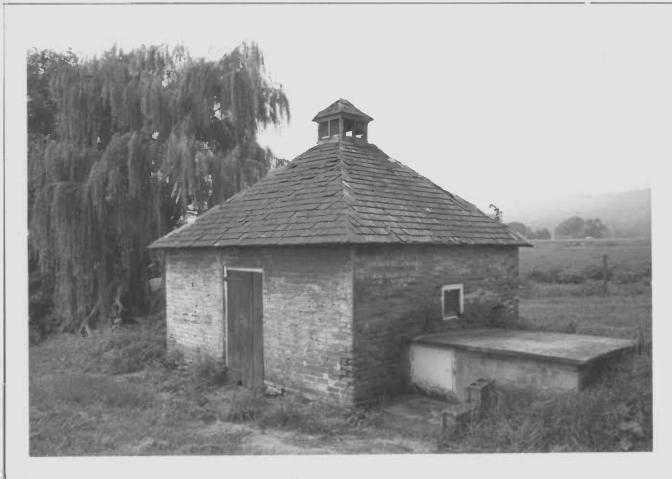
Springhouse: The square plan brick springhouse is located south of the house, while the other domestic outbuildings are located in a line extending east from the rear wing of the house. The springhouse has 5:1 brick walls and a hipped shingle roof with a central cupola. A vertical board door is located in the east elevation, and louvred windows are in the south and north elevations. The design of the building and its materials suggest that it dates from about 1850. The spring itself is covered by a modern concrete enclosure just north of the springhouse.

F-3-68 Frederick Cronse Formstead Frederick County Photo: Jonet Davis September 1992 Neg-loc. Md-SHPO Crownsville, Md Springhoose, northeast corner view 6/1

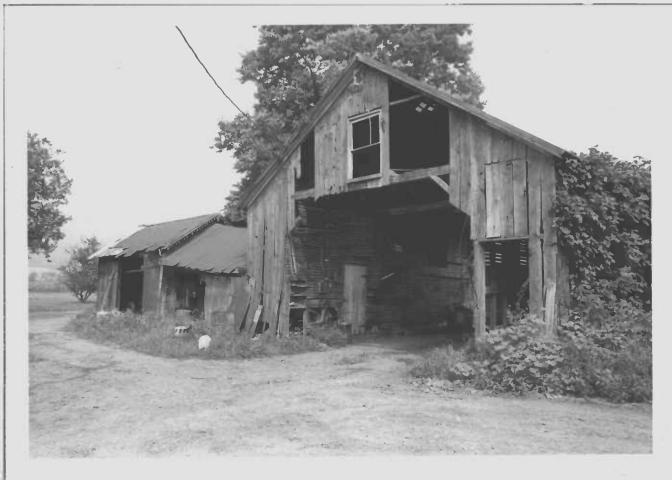
Log barn: The log barn is located east of the wagon shed and is not in use. The log structure is open, without chinking, and the roof is missing. Vertical siding apparently once covered the barn, but is only partly in place. A low opening on the south elevation suggests that it may have been used as a hog barn. Its date is probably about 1840-50.

4-3-68 Frederick Cronise Formstead Frederick County Photo: Jonet Dows Soptember 1992 Neg- loc. Md. SHPO, Crownsville, Md. Los born, south elevation 7/9
